# Failure mode analysis of Austria’s first road-integrated photovoltaic system

Alexander Erber\*

Competence Field Renewable Energy Technologies, University of Applied Sciences Technikum Vienna, 1210 Vienna, Austria

**Abstract.** The exploration of traffic areas as a novel photovoltaic integration opportunity within the traffic sector, specifically in road surfaces, has been demonstrated in various projects. Limited data and publications about the performance and failure modes of these innovative road-integrated modules highlights the need for a comprehensive failure analysis. This study focuses on first time assessing failure modes of road-integrated photovoltaic modules installed at Austria’s first road-integrated PV system in Teesdorf. A comprehensive failure mode analysis is conducted at the 100 m<sup>2</sup> PV parking place using a combination of quantitative and qualitative methods. These methods include regular visual inspections, I-V-curve measurements at both string- and module-levels (with a simplified STC correction), electroluminescence- and dark-I-V-curve measurements, and the use of monitoring data. The PV parking place produced 10.2 MWh in its first operation year

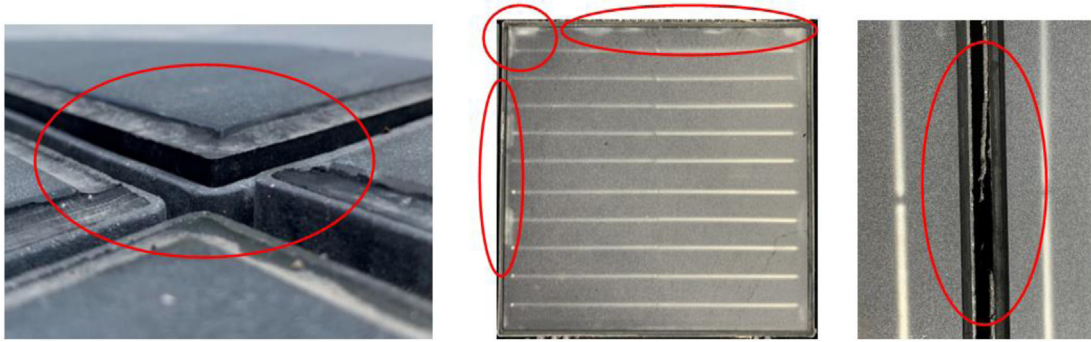
**Fig. 5.** Main material degradations found during visual inspections: Detachment of the top layer (glass-foil-module) from the base structure (left), delamination at the module glass edges (middle) and broken module edges (right).

The main failure modes found through visual inspection are presented in Figure 5. Three months after the systems commissioning, at some glass-foil modules detachments from the module substructure and break outs at the module edges were observed. This allowed water to enter the room between the glass-foil module and the substructure. The observed material degradations are not linked to a decrease in system or string power for the first year of operation. However, a connection with power losses due to module and cell short circuits was found in the second year (see Sect. 3.4). In addition to the detachment of the glass-foil modules and the broken edges, visually flawless modules also showed water ingress between the module glass and the module edges, as the seals on the module edges had come loose (only visible under very close inspection). These water ingresses were detected by a person walking over the modules.

As the inspections progressed, an increased occurrence of delamination at the module edges were detected. In conjunction with the material defects described above, this led to the replacement of 34 modules on 9<sup>th</sup> August 2022. Two modules of string 2.40 were replaced in this process as well.

In addition to the increasing number of modules with edge delamination, modules with already existing edge delamination showed an increase in the delaminated module area. Recognisable delamination above the cell surfaces (see Fig. 5.) indicates that the delamination is between the glass and the encapsulation. The delamination can be attributed to several possible causes. Firstly (1), delamination is favoured or caused by not optimally selected lamination parameters (temperature and pressure) [42]. Secondly (2), delamination could be favoured by the detachment of the glass-foil module from the module substructure – possible connection between the delamination at the module edges and the adhesive points. The third (3) possible cause is the stress caused by the vehicles during acceleration and braking. As these forces are not absorbed directly by the module frame and transferred to the module substructure via the glue point, the possible displacement of the module layers can reduce the adhesion to the neighbouring materials (cell, glass or backsheets) and cause delamination.

The breaking off of the module edges is primarily attributable to insufficient material thickness. In addition, the UV resistance of the substructure's copolymer material and missing expansion joints must not be disregarded as a further cause or accelerating influence. The latter mentioned is due to a planning error where the thermal expansion of the modules was not considered.

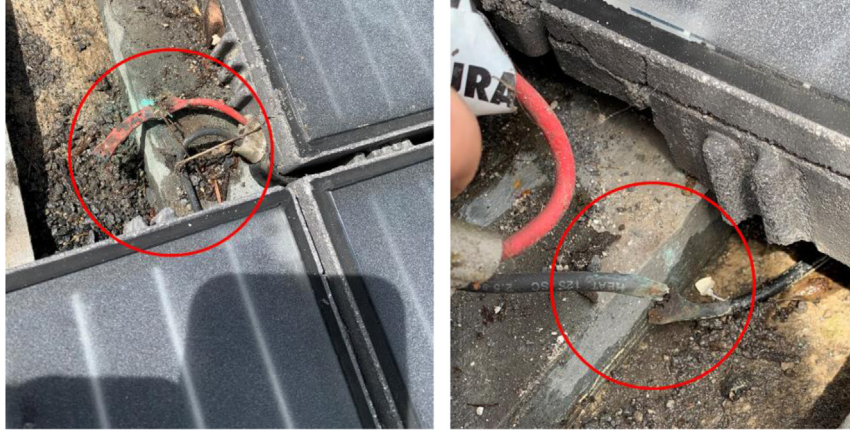
**Fig. 6.** Detected open-circuit positions at string 2.42 (left) and string 2.41 (right) with the signal transmission method.

During the operation time of the system two strings (2.42 and 2.41) went out of operation and an open circuit problem was identified as the cause of the failure. Through the signal transmission method, it was possible to locate the open circuit positions (Fig. 6). Crushed cables caused the open circuit due to either wrong installation or the thermal movement of the PV modules over time.

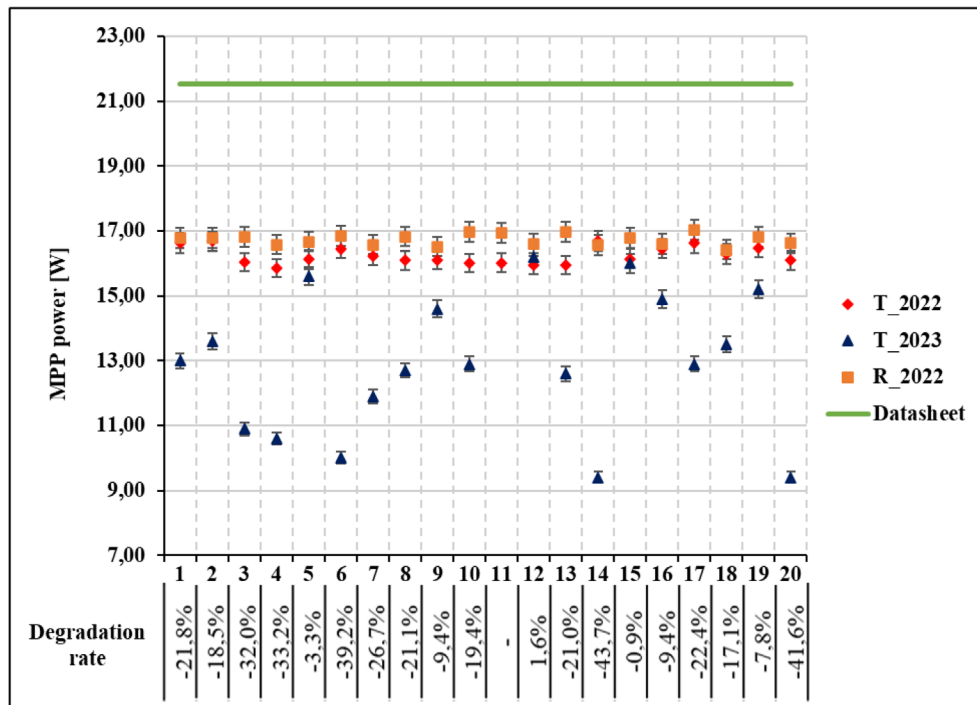
**Fig. 9.** Measured MPP power of the modules (indoor measurement) of string 2.40 (T\_2022 and T\_2023) and the reference string modules (R\_2022) compared to the data sheet value. Power values with the uncertainty range of the measurement device [35,36].

The results of the module I-V curve measurement at the AIT are shown in Figure 9 based on the MPP power. After commissioning, the modules of string 2.40 have a maximum output power that deviates from the data sheet (21.52 Wp) with an average of 16.25 Wp (T\_2022) and are 24.5% below the manufacturer's specifications. The same can be seen for the modules of the reference system (R\_2022) with an average output of 16.74 Wp (-22.2%). The measurements of the string 2.40 modules after one year (T\_2023) show a further reduction in output power to an average of

12.94 Wp (−39.9% compared to the data sheet value), whereby the outputs are more widely distributed (16.20 Wp to 9.40 Wp). Only three of the modules (5, 12 and 15) show no power losses when the measurement uncertainty is considered. A further analysis of the I-V curves is carried out in [27].

Based on the two measurements in 2022 and 2023, the degradation rate of the string 2.40 modules can be estimated at an average of 20.4% for the first year of operation. The fluctuation range is 1.6% to −43.7%.

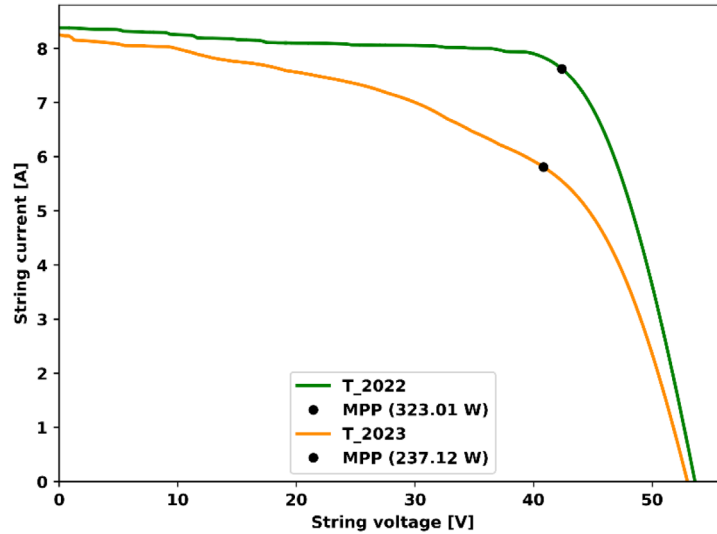
**Fig. 10.** String I-V curves of string 2.40 (calculated from the module I-V measurements at the AIT) for 2022 and 2023 (both indoor measurements).

Figure 10 shows the string I-V curves of string 2.40, which were calculated from the module I-V curves of the two AIT measurements (2022 and 2023). The string MPP power is 323.01 W after the system commissioning and 237.12 W after one year of operation. This results in a degradation rate at string level of 26.6%. The difference to the average module degradation rate of 20.4% can be explained by the current limitation of the weakest module. Considering the slope of the 2023 I-V curve at  $I_{SC}$  and the steps in the region of  $I_{SC}$  the drop in the filling factor, compared to the 2022 I-V curve, is attributed to cell cracks (drop of parallel resistance) (see Sect. 3.4) and delamination (see Sect. 3.1). With I-V curve measurements power losses can be calculated, but a clear assignment to failure modes solely on I-V data is not possible for all detected changes in the curves slope. Therefore, I-V curve measurements should be combined with other failure analysis methods (thermography, EL, etc.). For Figure 10, one could assume that failure modes affecting the series resistance, such as solder corrosion, homogeneous soldering disconnections or broken cell interconnect ribbons [28], are present, due to the slight change in the slope at  $V_{OC}$ . Although with EL (see Sect. 3.4) and visual inspections those modes can be ruled out. The slight change in the slope at  $V_{OC}$  and the reduction of  $V_{OC}$  is influenced by a low parallel resistance due to the cell cracks. With increasing cell cracks and inactive areas this change in the I-V curve will increase.

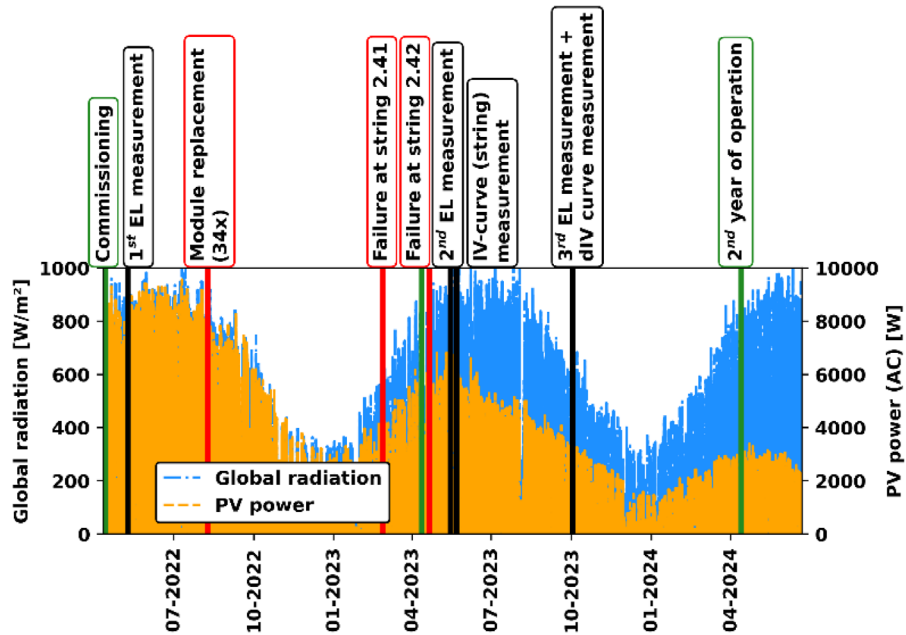
In the first year of operation, the yield of the PV parking place is 10.2 MWh (spec. 100 kWh/m<sup>2</sup>), which corresponds to a deviation of 27.14% from the expected yield of 14 MWh (calculated through simulation in PV\*Sol<sup>®</sup> Premium). The reason for this deviation is due to the reduced module power compared to the data sheet value at the time of installation and further power degradations during the first year of operation. Figure 11 shows the increasing deviation of the correlation between irradiation and PV power (AC) in spring 2023. The figure also shows the timestamps of the conducted measurements, failures and module replacements. Due to a power share of 2.5% (based on the number of modules), the failures of string 2.41 and string 2.42 are not visible. The failure causes of string 2.41 and 2.42 were identified through the measurement of the open circuit voltage. As explained in the previous section the open circuit positions were found with the signal transmission device.

**Fig. 11.** AC power output of the PV parking place. Global radiation of the weather station in Gumpoldskirchen and marked time events (green = operating time, red = string outages problems, black = measurements).

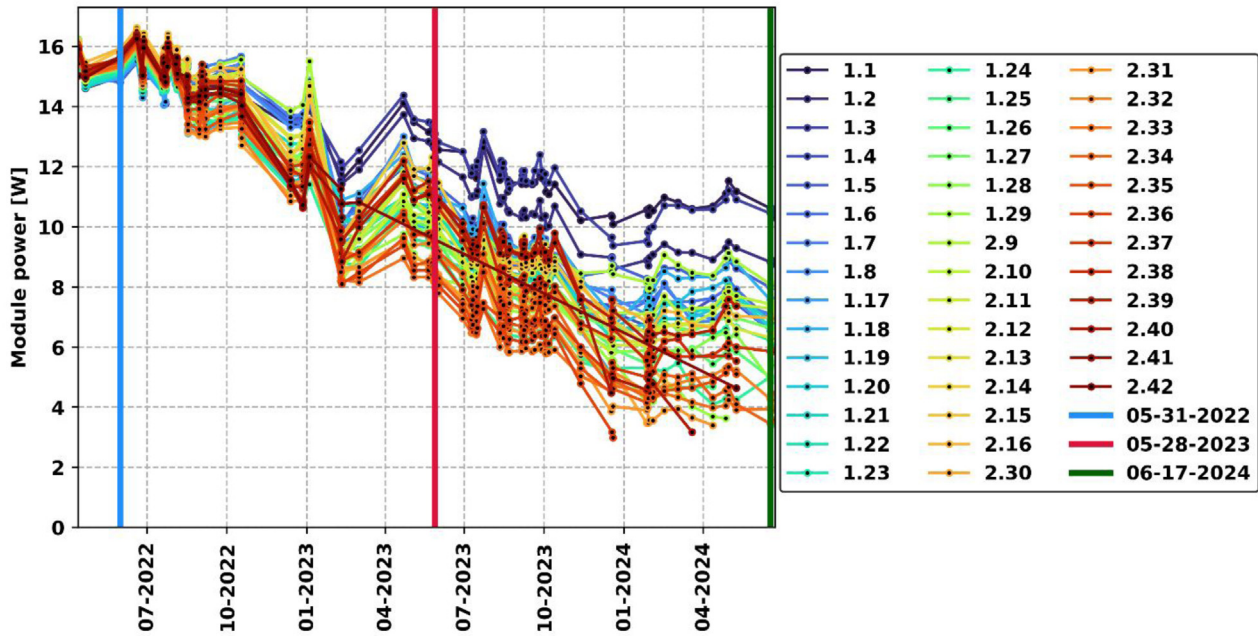
Fig. 13. Evolution of the STC corrected string powers (shown as module-normalised power) on the selected clear-sky days.

In comparison to Figure 11, a reduction in power can already be seen in September 2022, which continues until the end of the observation period. The string powers show an increasing spread over the operating time. The correlation between string position in the system and power reduction is also recognisable here – strings that are in middle of the systems or closer to the municipality centre degrade faster as more cars park there. The fluctuations and outliers in the power curves are due to soiling, self-cleaning by rain and the developed temperature model. Based on the monitoring data, the average power losses of the strings in the first year of operation (comparison of 31<sup>st</sup> May 2022 with 28<sup>th</sup> May 2023) are 33.5% with a spread of 13.8% to 47.8%. For the second year of system operation (comparison of 31<sup>st</sup> May 2022 with 16<sup>th</sup> June 2024) average power losses of 56.2% with a spread of 29.2% to 77.5%. However, 18 strings were no longer in operation on 16<sup>th</sup> June 2024, as the string voltage was below the starting and operating voltage of the inverters.

pattern. This further indicates that the power losses after October 2023, shown in Figure 13, are due to cell and module short-circuits.

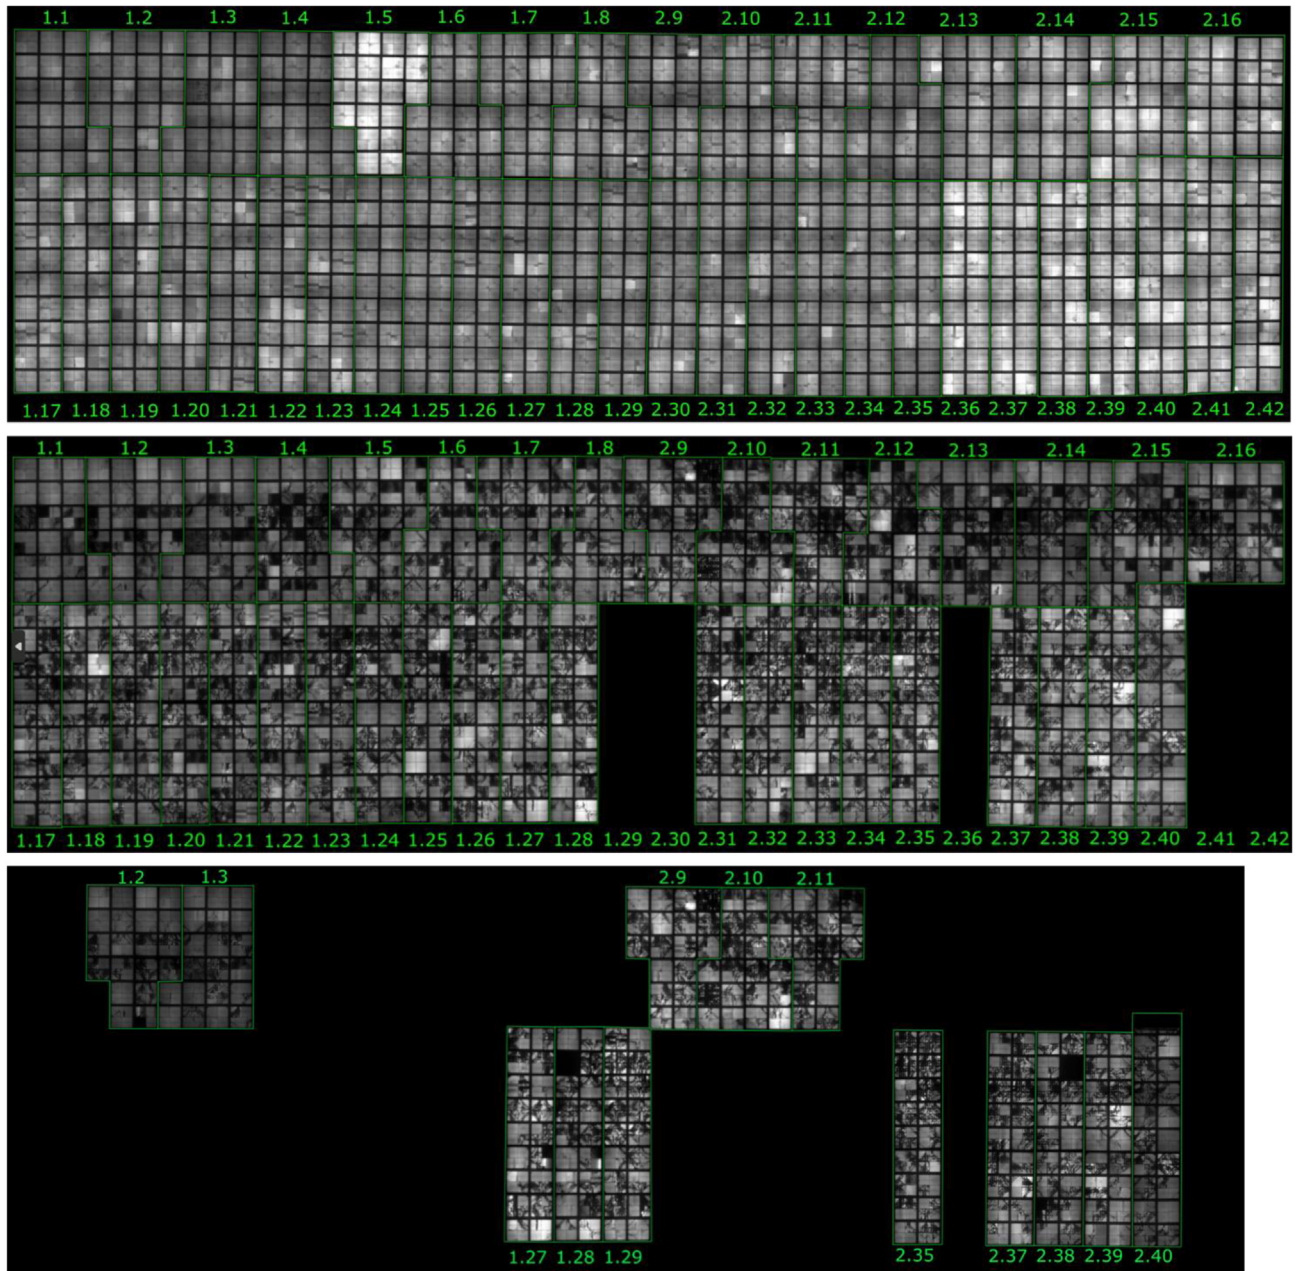
In the EL image of 2022, the modules show differences in the local series resistance – evident through the contrast differences in the module and string. These contrast differences are due to contacting problems at the soldering points (modules 2, 3, 5, 9, 12, 15 in Fig. 15). Furthermore, cell cracks of type A are visible (modules 3, 4, 5 and 8 in Fig. 15). As the first EL image was taken approximately one month after commissioning, the cell cracks may have occurred either during module production or in the first month of operation.

The EL image of May 2023 confirms cell cracks and cell fractures as the main cause of the power losses. A comparison of the images (May 2022 with May 2023) shows a significant increase in cell cracks and cell fractures. Most cell cracks can be classified as type B and type C, with type C cell cracks being the most frequent. Modules with cell cracks or cell fractures show almost the same fracture or crack pattern – diagonal cracks with active cell areas at the outer cell edges. Based on the repeating patterns, the cause of the cell cracks and cell fractures are attributed to the vehicle load and the inadequate support of the glass-foil module by the substructure of the analysed module. In addition to modules where all four PV cells show diagonal cracks, there are also modules with only one to three affected cells. The reason for this could be a difference in wafer/cell quality [44] or an asymmetrical load on the modules (e.g. vehicle tyres only apply load to the edge of the module).

In addition to the cell cracks, short-circuited cells in strings 1.2, 1.27 and 2.38 and short-circuited modules in strings 1.28 and 2.38 are seen (October 2023) in Figure 14.

**Fig. 14.** EL images of the PV parking place in May 2022 (top), May 2023 (middle) and October 2023 (bottom) with string label.

Short-circuited cells occur when both cell poles are short-circuited by moisture due to delamination. At module level, the cause also appears to be due to water ingress between the glass-foil module and the module substructure, where the bypass diode is located. The outage of 18 strings in June 2024, due to too low voltage, shows that the number of short circuits (module or cell) increased in the second year of operation.

The strings with the least cell cracks are string 1.1, 1.2 and 1.3, which are located on the side of the cable ducts and are the furthest away from the entrance to the community centre. It must therefore be assumed that cars were parked less frequently in these parking places compared to other.

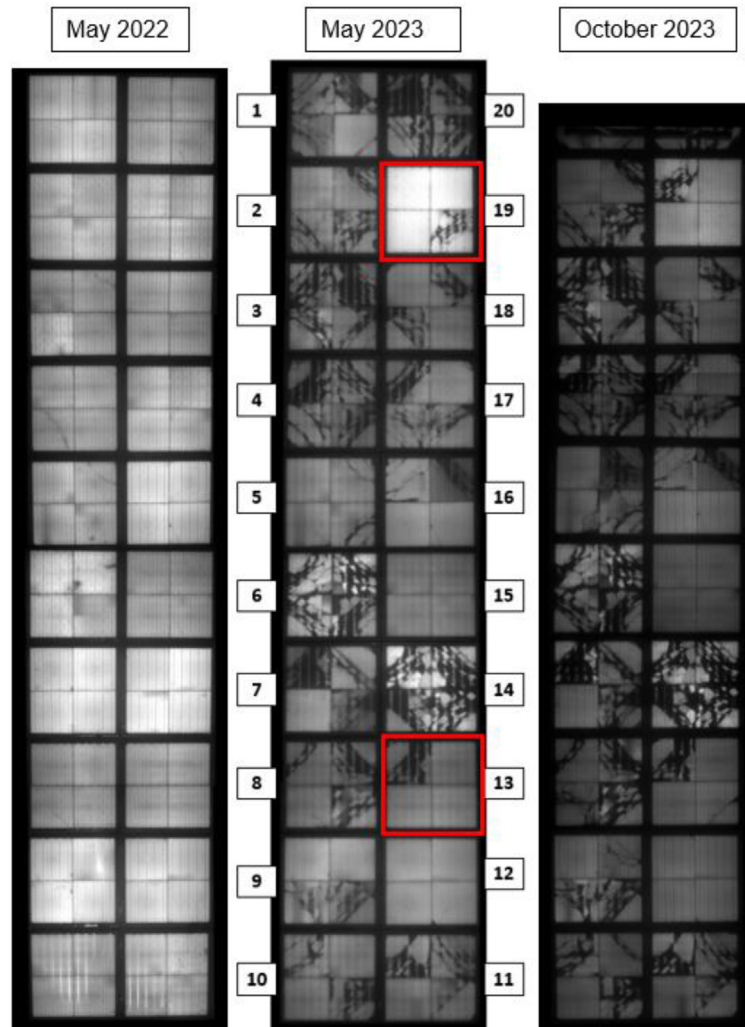
The possible development of the cell cracks over time can be seen in module 5 in string 2.40: Starting from a semi-circular continuous crack at the outer cell corner, finer cell cracks and cell fractures occur over time, which move towards the centre of the module.

The inactive cell areas of the EL image of string 2.40 from May 2023 in [Figure 15](#) show a high correlation with the MPP power data in [Figure 9](#). Two modules (modules 12 and 15) in string 2.40 are noticeable, with no recognisable cell cracks until October 2023. The situation is similar for other strings. A lower mechanical load on these modules can be ruled out with a high degree of certainty due to the cell cracks in the neighbouring modules.

The EL image of string 2.40 ([Fig. 15](#)) shows that there is only a slight increase in cell cracks between May 2023 and October 2023. Modules 2, 3, 6, 7, 11, 14, 16, 17 and 19 of string 2.40 show no or marginal changes in the crack

**Fig. 15.** EL images of string 2.40 in May 2022 (top), May 2023 (centre) and October 2023 (bottom). The numbering corresponds to the module numbers in Figure 9. Replaced modules are marked in red.

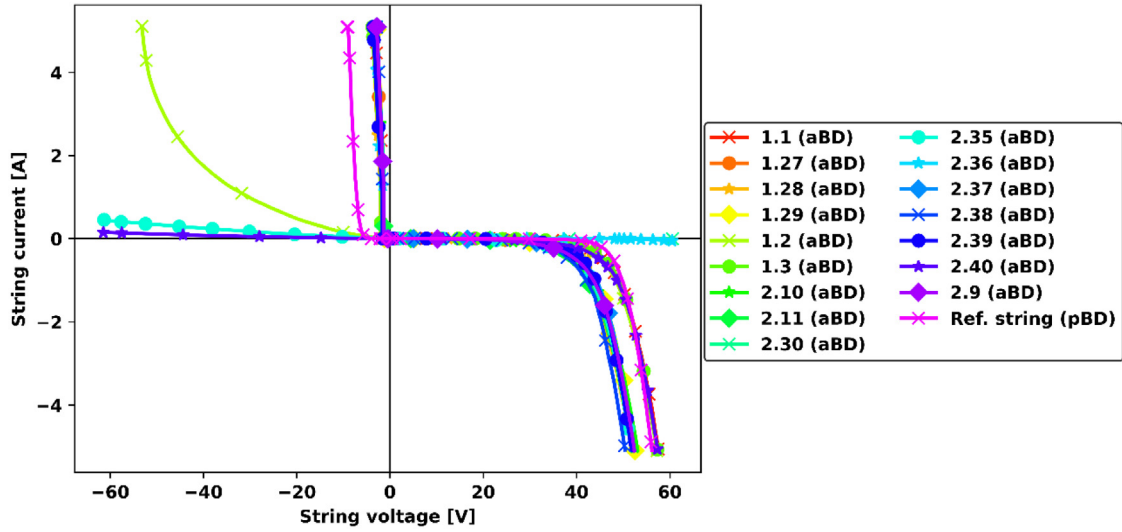
In addition to the string dark I-V curves of PV parking place, the dark I-V curve of the reference string with 20 modules (Ref. string) is shown in Figure 16. In the reverse voltage quadrant, this string shows the diode characteristic of 20 passive bypass diodes (pBD), which have higher voltage drops than the active bypass diodes (aBD) installed in the rest of the RIPV modules.

**Fig. 16.** Dark I-V curves of all measured strings at the PV parking place (x.xx) and reference string (ref. string). The abbreviation in brackets refers classifies the present bypass diode type in the strings (aBD = active bypass diode, pBD = passive bypass diode).

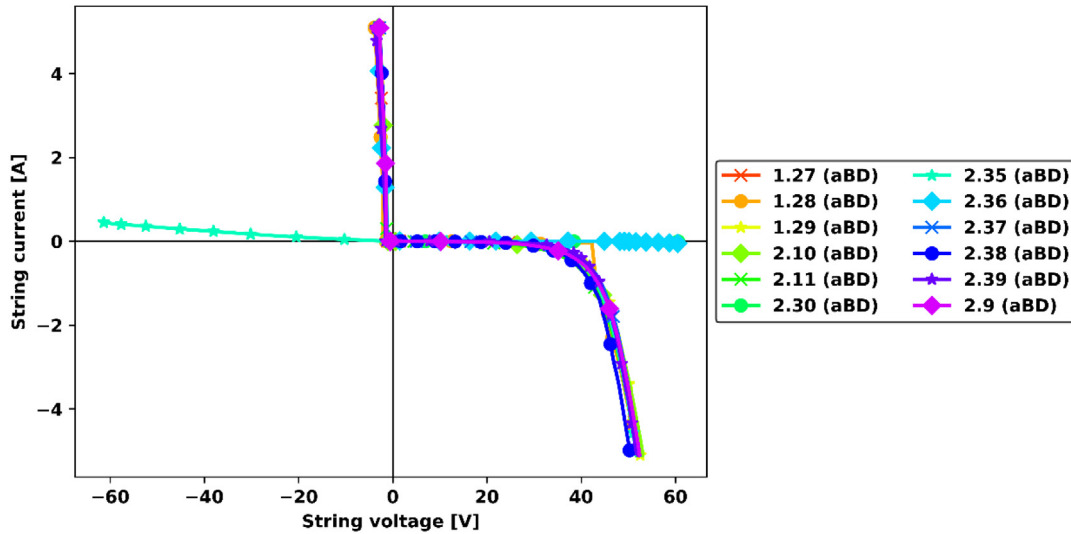
As Figure 16 shows strings with different numbers of modules and therefore faults in the forward bias quadrant are more difficult to recognise, Figure 17 illustrates strings with 18 modules. A buckle in the dark I-V curve of string 1.28 (orange) is recognisable, which is due to an electric arc.

**Fig. 17.** Dark I-V curves of all measured strings with 18 modules.

The affected module could not be localised as the arc was not visually detectable during the measurement. The affected area in the module is initially non-conductive at low voltages and becomes conductive at higher voltages due to the arc. Second, a voltage difference can be seen at string 2.38 and 1.28 (overlap of the dark I-V curves) compared to the remaining strings with 18 modules. This voltage difference is caused by one short-circuited module in each string. Due to the low open-circuit voltage of the modules and the number of 20 bypass diodes in a string, the exact identification of a module short-circuit is difficult without the inclusion of an EL image.
