Advanced analysis of backsheet failures from 26 power plants

Abstract. Backsheet degradation is a known reliability issue affecting field-exposed photovoltaic (PV) modules power plants. In this work, we present lessons learned during the last three years, examining modules from 26 power plants in the TestLab PV Modules at Fraunhofer ISE. The basis is a description of the currently observed backsheets and associated degradation features as for example backsheet chalking, cracks in different layers and chemical changes in composition. Furthermore, we lay out analytical methods for initial and more detailed analysis of the failures and module materials. For example, a method designated as “flashlight test” has been found to provide a quick and straightforward method to identify damaged polypropylene (PP) layers within backsheets. Furthermore, scanning acoustic microscopy (SAM) and a comparison of different variants of FTIR spectroscopy are presented.

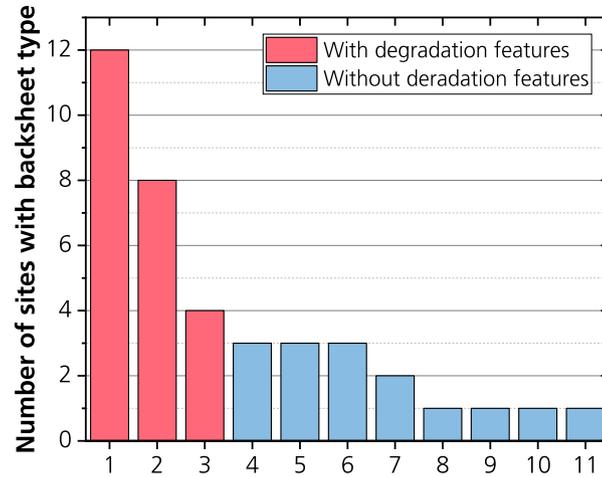
Fig. 1. Left: List of layer structures found in the investigated backsheets; Right: Graph showing the number of sites on which each respective backsheet type was found.

Polyamide backsheets were the most common types (reported from 12 sites) which were found during analysis and is certainly a known critical material [8]. Other critical material stacks were F-C/PET/PP (8 sites) and PET based structures (e.g., PET/PET/PET) (4 sites). Backsheets 1–3 from the table in Figure 1 (left) revealed to be the most relevant backsheets in terms of degradation and associated failure modes are shown and quantified in Figure 2. However, it is not clear to what degree these findings are representative for all backsheet products that contain these material combinations, because quality can range between different manufacturers and suppliers. It is merely an indication that at least some backsheets containing these materials showed critical degradation after field-exposure. Backsheet structures 4–11 listed in Figure 1 (left) were inconspicuous in terms of degradation

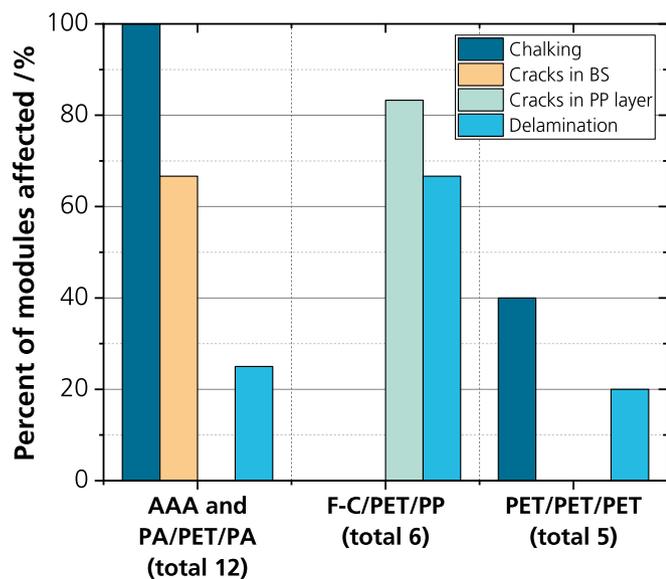
**Fig. 2.** Distribution of the failures in the most relevant degraded backsheet structures after several years of operation.

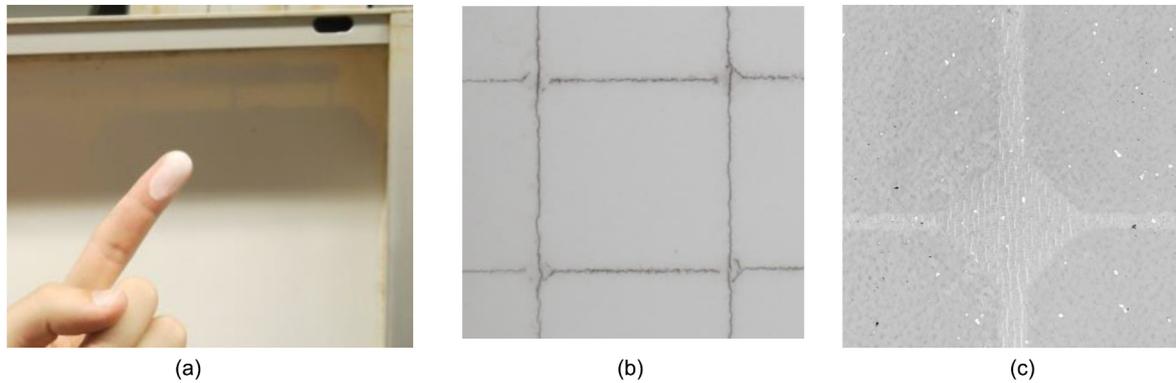
All modules with polyamide backsheets (AAA and PA/PET/PA) as well as 40% of the PET based backsheets deposited a white powder (Fig. 3a), known as chalking [9], on the rear surface after field exposure. 67% of the investigated backsheets with polyamide developed cracks Figure 3b, typically in the cell gaps, suggesting a degradation mechanism initiated by front side UV radiation [2], or along the cell connectors, indicating the appearance of thermo-mechanical stresses in these regions. The PET based foils, on the other hand, showed no visual defects besides chalking and insulation issues have reported from one module only. This suggests that there might be a connection between chalking and the formation of backsheets cracks in polyamide layer structures. Furthermore, it has been demonstrated that, moisture inside the polymer plays a synergistic role with UV in the formation of backsheets cracking [10,11]. Backsheet chalking in AAA

layer structures can therefore be evaluated as an early warning sign that indicates an elevated probability for the presence of a critical material and possible crack development in the future.

Fig. 3. Images from different degradation features; (a) Chalking on rear side of a polyamide backsheet [9]; (b) Cracked AAA backsheet; (c) Small cracks, indicating a damaged PP layer in a F-C/PET/PP backsheet.

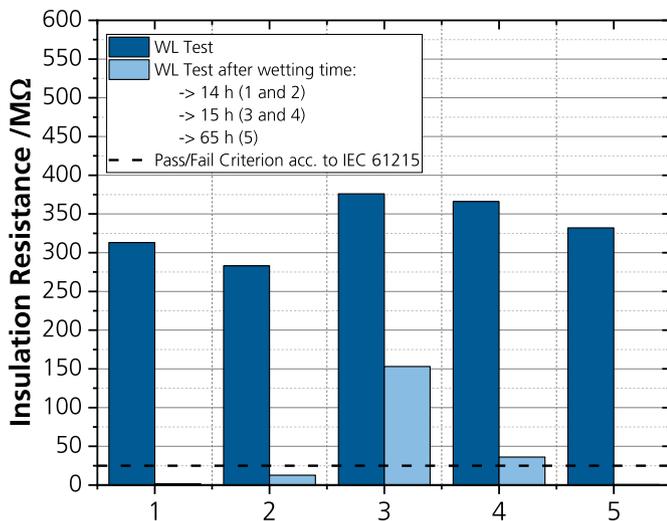
Five additional modules that passed the first WL test were subjected to an extended wetting time in a water bath for 14 h, 15 h and 65 h, respectively, before the WL test was applied for a second time. This was done in order to reproduce low insulation resistance values that had been observed in the field and had led to inverter outages. All five modules used the same backsheets foil: F-C/PET/PP. The measurements showed a strong decrease of the insulation resistance values in the modules after the extended wetting time (Fig. 4), which coincides well with the observed inverter outages. A control experiment on field-aged modules without detectable backsheets degradation, in contrast, showed no significant change in insulation properties upon longer wetting time. This suggests that an increased wetting time beyond the test conditions according to IEC 61215-2:2016 (MQT 15) can be required to detect low insulation properties that lead to inverter outages.

Fig. 4. Wet leakage current test results of five exemplary modules with F-C/PET/PP backsheets from two power plants that have been measured initially and after extended wetting times in a water bath of 14 h (modules 1 and 2), 15 h (modules 3 and 4) and 65 h (module 5).

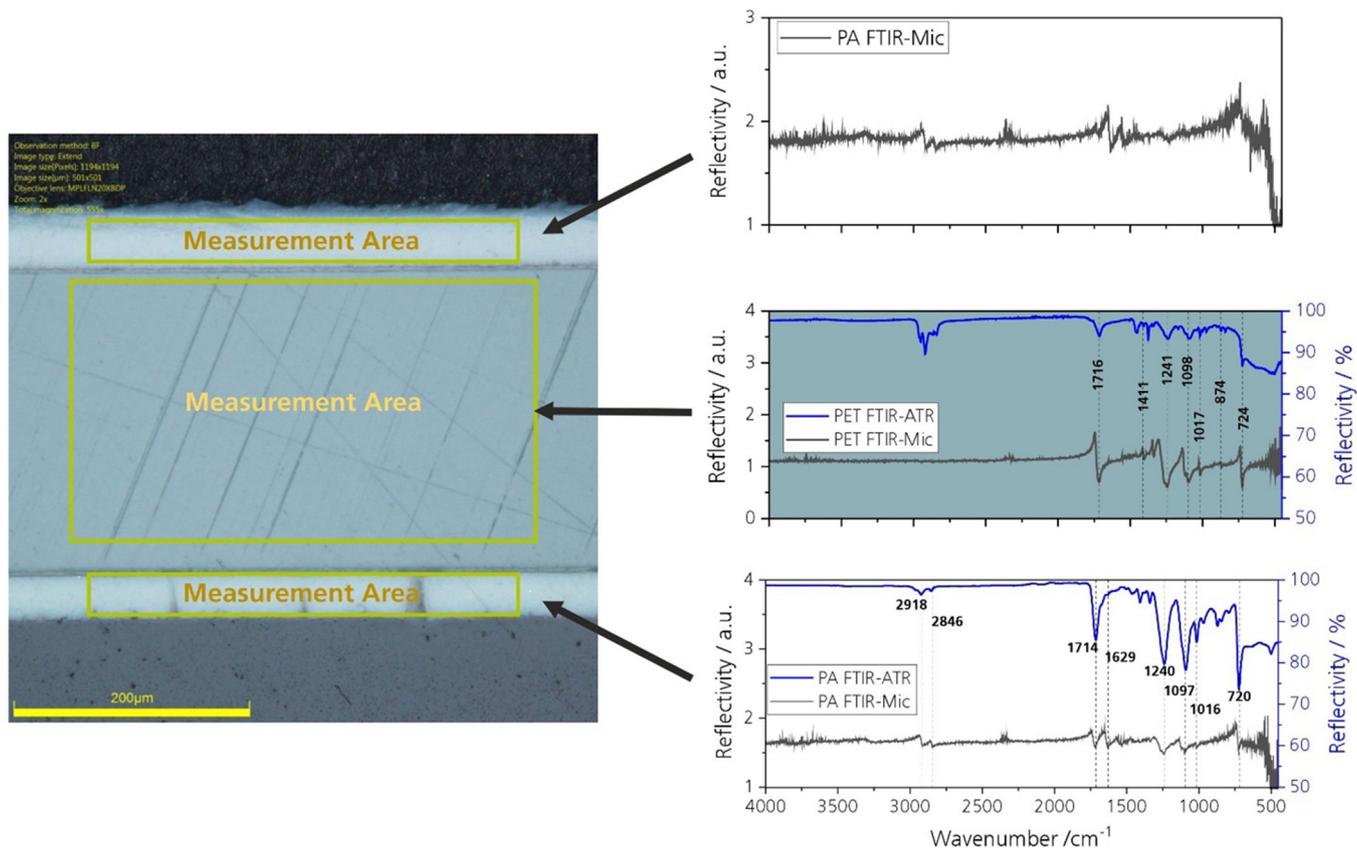
The PET layer, which can be found in the core of the backsheet in the left image of Figure 5, is shown in a comparison of the FTIR-ATR spectrum with the FTIR-microscope spectrum. As indicated by the vertical markers, all significant peaks of the FTIR-ATR spectrum can also be observed in the FTIR spectrum of the PET layer.

The spectrum of the outer layer of the APA backsheet, despite the noisier signal is sufficient for a qualitative statement: The FTIR-microscope spectrum has five peaks that coincide well with the FTIR-ATR spectrum: Peaks at 1097 cm^{-1} , 1240 cm^{-1} , 1719 cm^{-1} , 2846 cm^{-1} and 2918 cm^{-1} .

Fig. 5. Left: Microscopy image of the multilayer PA/PET/PA backsheet cross-section in a PV module. Right: Comparison of FTIR microscopy spectra (black) of cross-section samples and ATR-FTIR spectroscopy spectra (blue) of separated backsheet surface layers.

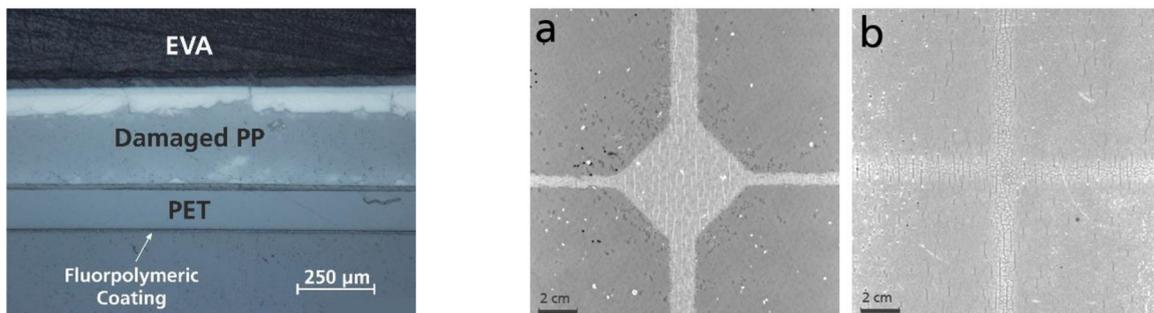
Hidden damages in the inner PP layer were found in F-C/PET/PP structures, despite a regular outer appearance of the backsheets. Cross-sectional images (Fig. 6, left) revealed severe damage in the cell gaps within the backsheets in more than 80% of the investigated modules with this backsheets type. The location between the cell gaps indicates one more time a degradation mechanism due to UV radiation. Illumination of the modules from the front side, sometimes referred to as “flashlight test” was found to be a straightforward and cheap method to identify affected modules. This can be done with a flashlight, shining through the backsheets in the cell gaps. On the rear side, the shadows of the tiny cracks in the PP layer become visible, similar to the image taken of an affected backsheets with a scanning acoustic microscope in Figure 3c. This method can serve as a first indication of cracks inside the layer structure. A clear disadvantage of this method is that only the cell gaps can be analyzed and cracks along the busbars remain undetected.

Fig. 6. Left: Cross section of a F-C/PET/PP coating with damaged PP layer. Right: Acoustic images of the multilayer backsheets in a field-exposed PV module; (a) core/inner layers interface of F-C/PET/PP backsheet; (b) outer/core layers interface of PA/PET/PA backsheet.

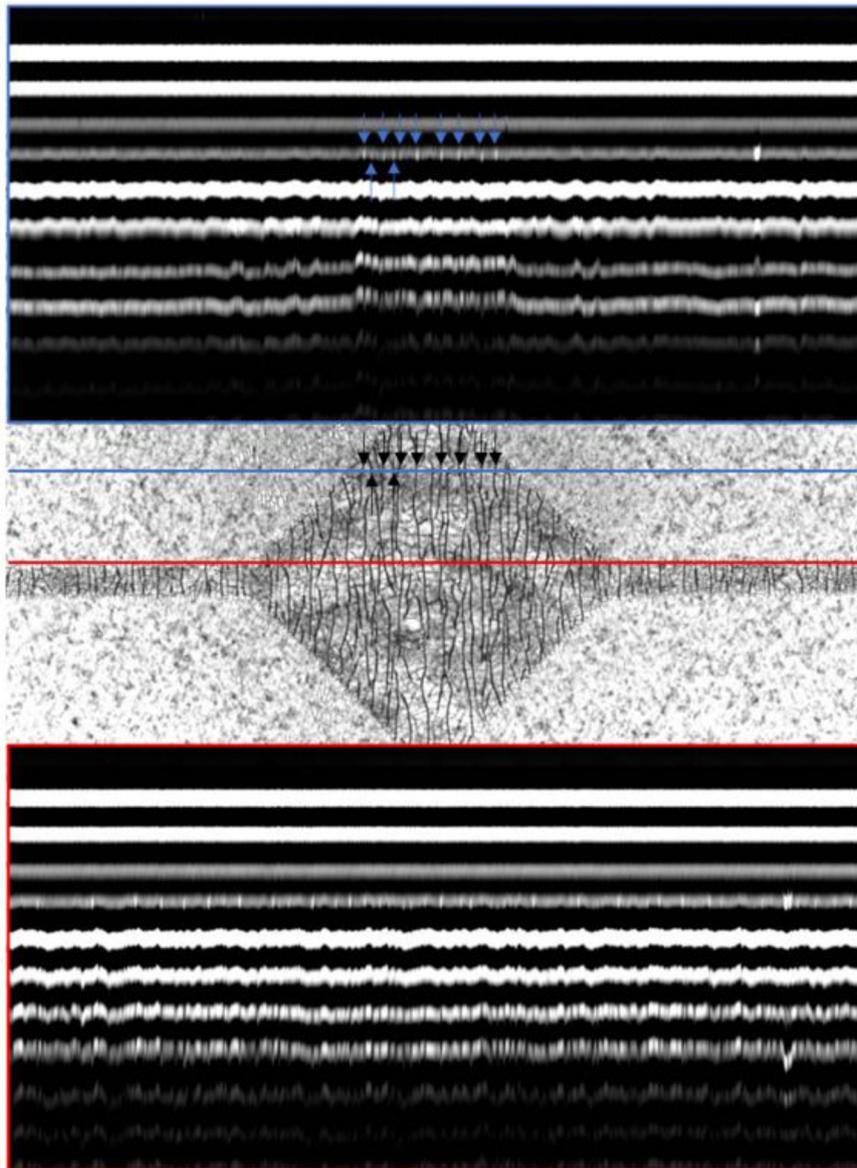
F-C/PET/PP backsheet and in Figure 8 for the module with APA backsheet. The corresponding backsheet cracks in the upper lines are marked with arrows for the comparison between the acoustic micrographs in the middle and the acoustic cross-section on the top.

The acoustic cross-sections confirm the same crack positions within the layer stack of the different modules. For modules with F-C/PET/PP backsheet, the cracks are visible at the 4th interface starting from the top line, which means at the backsheet inner/EVA layer

Fig. 7. Acoustic cross-sections of a module with F-C/PET/PP backsheet revealing internal cracks (top and bottom), taken at the lines indicated in the micrograph (middle).

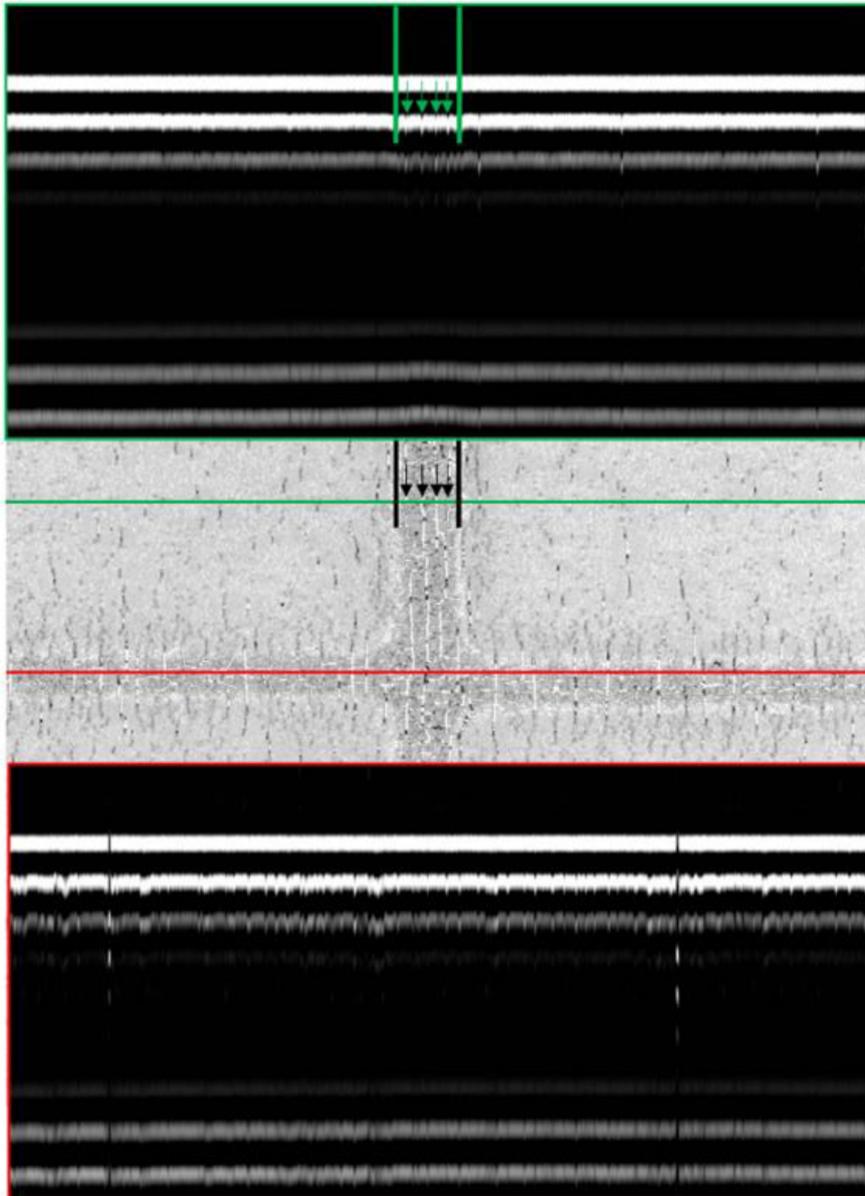
interface. This coincides well with the results of optical microscopy (destructive) of the same material (Fig. 6, left). For the module with APA backsheet, the cracks appear slightly earlier at the 2nd interface, i.e., the outer PA/core PET layer interface. This coincides well with the results of optical microscopy (destructive) of the same material (Fig. 5, left), whereas, for the module with APA backsheet, the cracks appear slightly earlier at the 2nd interface, i.e., the outer PA/core PET layers interface.

Fig. 8. Acoustic cross-sections of a module with PA/PET/PA backsheet with polyamide outer layer cracking (top and bottom), taken at the lines indicated in the micrograph (middle).
