# Photovoltaic failure diagnosis using imaging techniques and electrical characterization

**Abstract.** Inspections of 48 photovoltaic (PV) modules within a 302.4 kWp solar array were undertaken to expose the presence of defects after 12 years of operation under the harsh environmental conditions of Djibouti. To this end, a multiple-technique testing protocol was conducted including visual inspection (VI), infrared thermography (IR), current-voltage curve characterization (I-V), ultraviolet fluorescence (UVFL) and electroluminescence imaging (EL). The main visible degradation features observed were discoloration, bubbling and snail trails with occurrences of 100%, 93.7% and 2.1% respectively. According to the IR imaging results, hotspots were observed on cells affected by snail trails. IR was combined with convolutional neural network (CNN) techniques to automatically detect the different classes of failures that PV modules may experience. EL imaging reveals that the cracks of the cells underlie the observed snail trails during visual inspection and UVFL imaging. In addition, a decrease in STC power was observed after 12 yr of operation with a median reaching 5.5% corresponding to

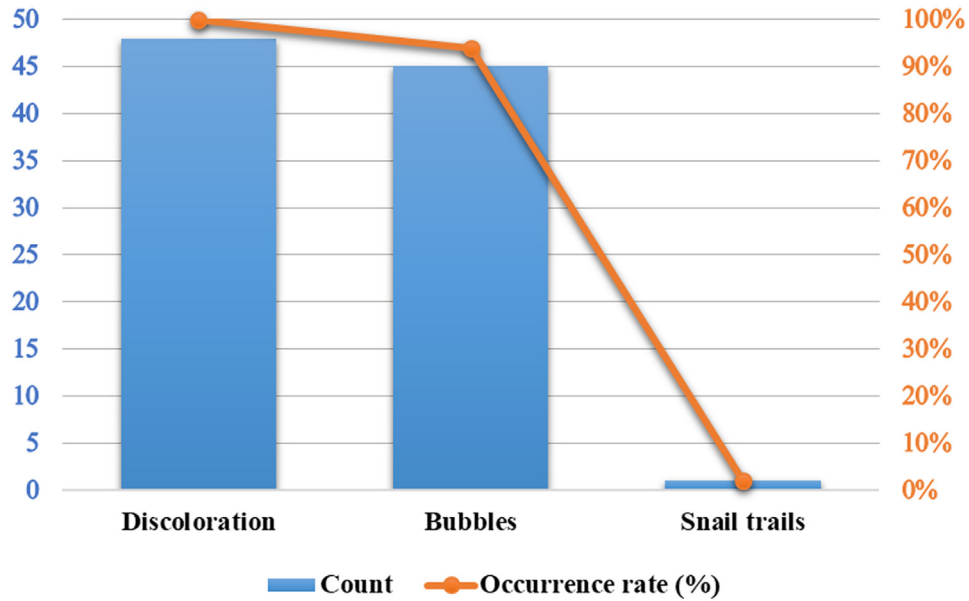
During the visual inspection, numerous defects were discovered, including encapsulant discoloration, snail trails and backsheet bubbling. A detailed description of the visual inspection results is shown in Table 3. A summary of the statistical analysis and evaluation of the degradation of the PV system component is displayed in Figure 9. Encapsulant discoloration was observed to be the most

common degradation mode in all PV modules. It was followed by backsheet bubbling and snail trails, which occurred in 45 over 48 modules (93.7%) and 2.1% of the cases respectively.

Fig. 9. Frequency count and occurrence of observed degradation during visual inspection.

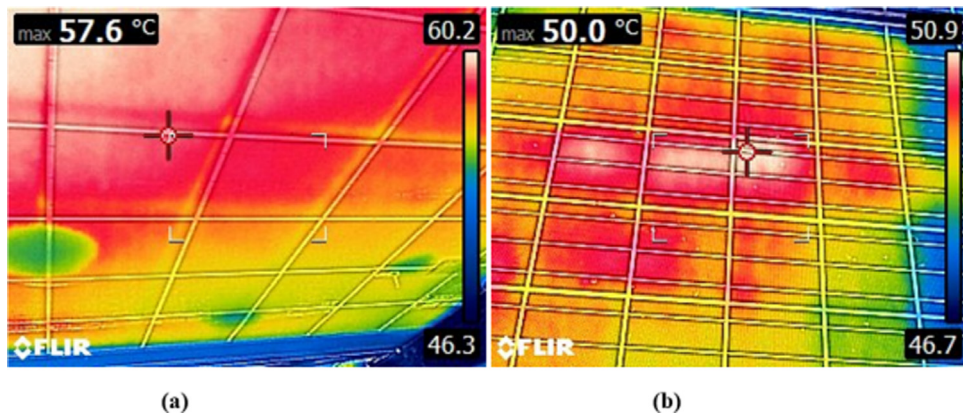
The observed defects on visual inspection were thoroughly analyzed through infrared thermography with the PV installation in operation. Figure 10 shows the infrared images of the front and rear sides of a module presenting bubbles. By analyzing these IR images (Fig. 10a), the exact location and the accurate size of the bubbles can be discerned. They are discernible and indicated by a greenish coloration. Based on the temperature gradient displayed in the image, the areas affected by this degradation had a lower apparent temperature than the rest of the backsheet, of around 50°C. On the front side, the infrared image indicated the presence of hotspots at an apparent temperature of 50.9°C (Fig. 10b) on certain cells according to the hot spot detection algorithm. These cells were precisely located where the bubbles were situated.

Fig. 10. Infrared images of bubbles on a PV module viewed on the backside (a) and on the front side (b).

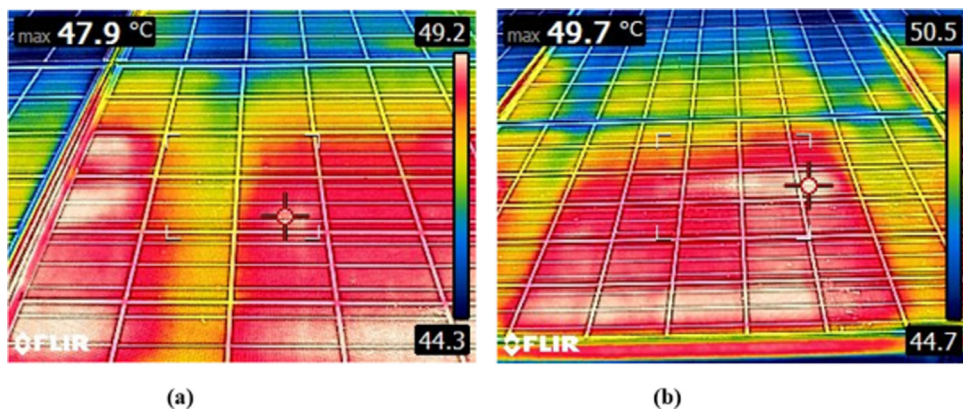
Figure 11 shows the IR images of a module presenting several snail trails. Multiple cells were found to exhibit relatively high temperatures with differences of 5 to 6°C. Indeed, hot spots were expected to be associated with snail trails since they are known to have a detrimental impact on the performance of PV modules and may serve as an indicator of moisture ingress, often attributed to mechanical stress resulting from the loss of module hermeticity and cell cracking.

Fig. 11. Infrared images of snail trails on a PV module viewed on the edges (a) and on the center (b).

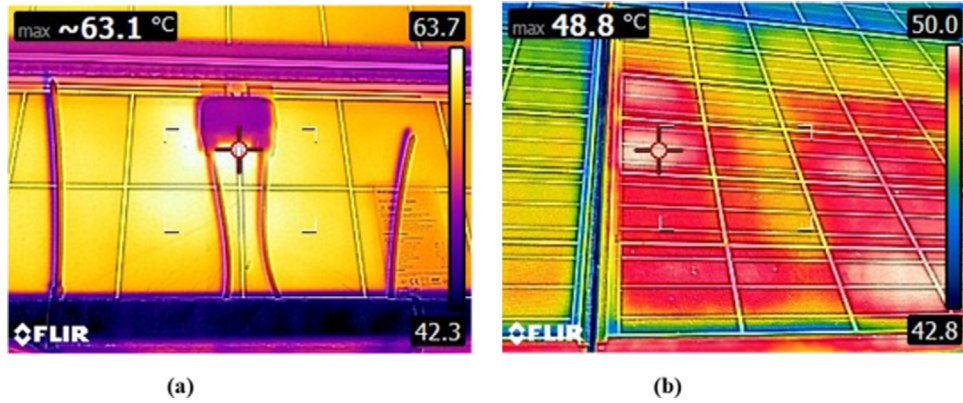
One of the key findings from the IR imaging analysis was that all solar cells located directly on top of the junction boxes were approximately hotter than the other cells with a temperature difference from 8°C to 13°C (Fig. 12). On the rear side of the PV module, it could be noticed that the temperature of the junction box was extremely elevated as high as 63.7°C. This indicated that more cell thermal stress may have occurred at these locations and as a result led to hot spots [48]. A higher temperature was observed when the bypass diode inside the junction box was activated.

**Fig. 12.** Infrared images of the junction box of a PV module on the backside (a) and on the front side (b).

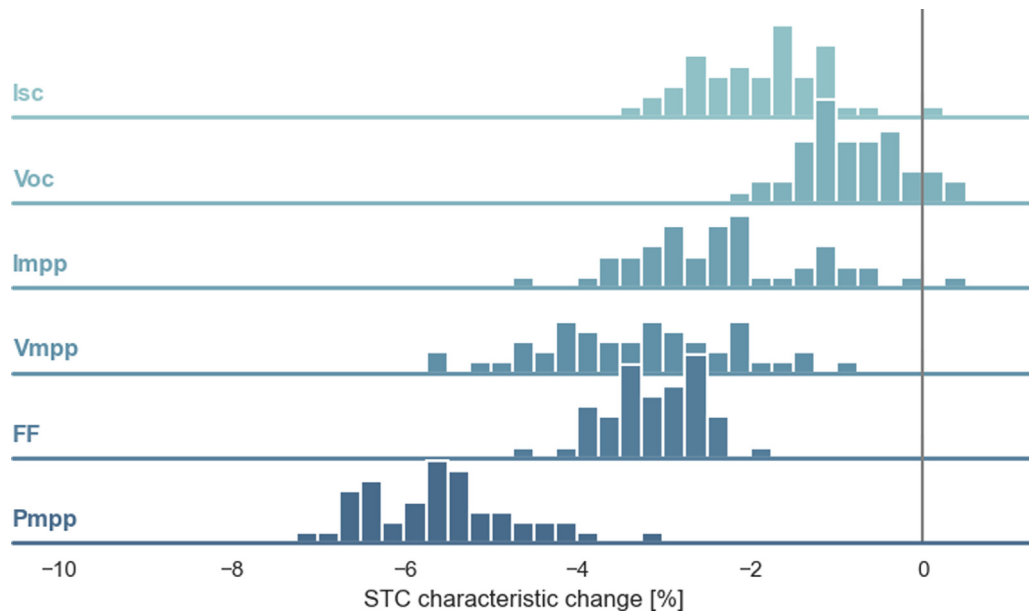
For almost all the tested modules, a decrease in all the studied characteristics was observed compared to the initial assumed datasheet STC values. The evolution of each electrical characteristic is shown in Figure 14 and Table 4.

From [Figure 14](#), it can be observed that the characteristic points at the axis-intercepts with  $I_{sc}$  and  $V_{oc}$  were moderately impacted with a median decreasing by not more than 2%. The decrease at the operating points  $I_{mpp}$  and  $V_{mpp}$  had a wider distribution, but also exhibited a higher degradation with medians over 2%. The Fill Factor (FF) decreased within a range of 4.6% to 1.6% testifying for degradation on the resistance in series and in parallel. Overall, all the modules showed a decrease in STC power after 12 years of operation with a median reaching 5.5% corresponding to an average degradation rate of 0.46%/year which was well in line with silicon technology rates found in the literature [8,49].

**Fig. 14.** I-V characteristic degradation after 12 yr of operation on a population of 48 modules.

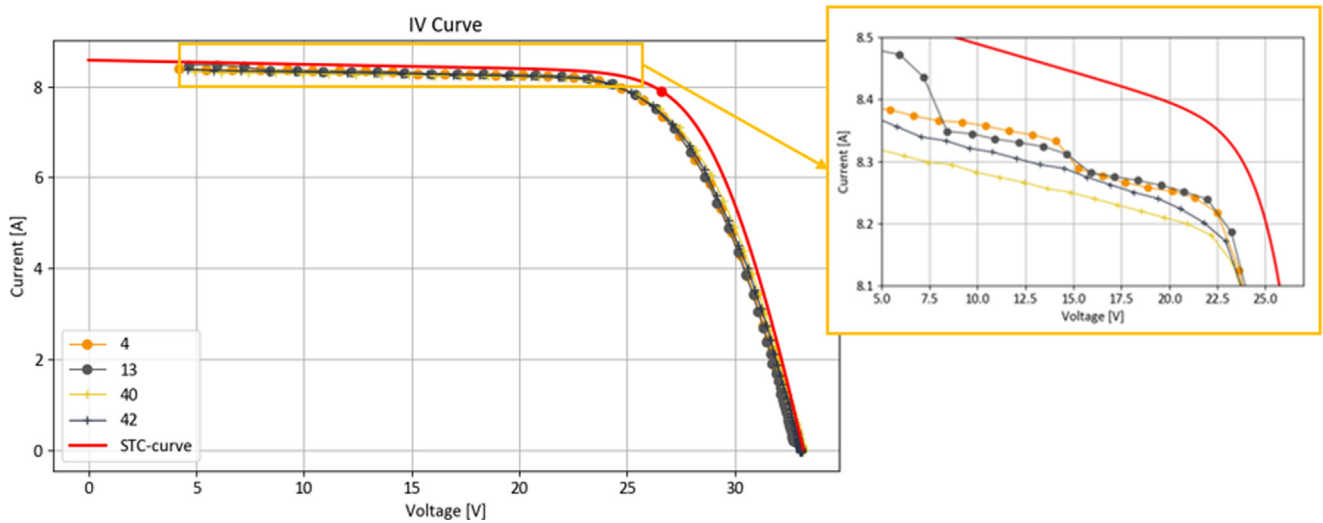
Upon closer inspection, some I-V curves were found to contain several degradation features. This is illustrated in [Figure 15](#), which shows a module exhibiting increased slopes at the  $V_{oc}$  intersection from all measured I-V curves. The more pronounced slopes are a feature of the

degradation of the resistance in series  $R_s$ , which can typically increase when the electrical circuit is deteriorated caused by, for instance, a higher corrosion level due to aging mechanisms. It must be noted that the measured I-V curves do not attain the  $V_{oc}$  due to the STC translation which shifts the curve to account for the temperature difference between the measurement and the STC conditions.

Then, when zooming on the section between 5 V and 25 V in [Figure 15](#), the slopes from modules 40 and 42 are sensibly smooth and almost parallel to the STC curve, but not for modules 4 and 13. For the latter two modules, a cascade of steps decreasing the current at around 7.5 V–8 V intervals indicates some mismatches in the current generation between the three cell strings, which are separated with bypass diodes in the module. This mismatch between the three cell strings is more clearly identified in [Figure 16](#) on module 13 where each cell string has a distinctive maximum current level. These mismatches are typical when the module

**Fig. 15.** I-V curves of the PV modules 4, 13, 40, 42 with the initial STC curve (red).

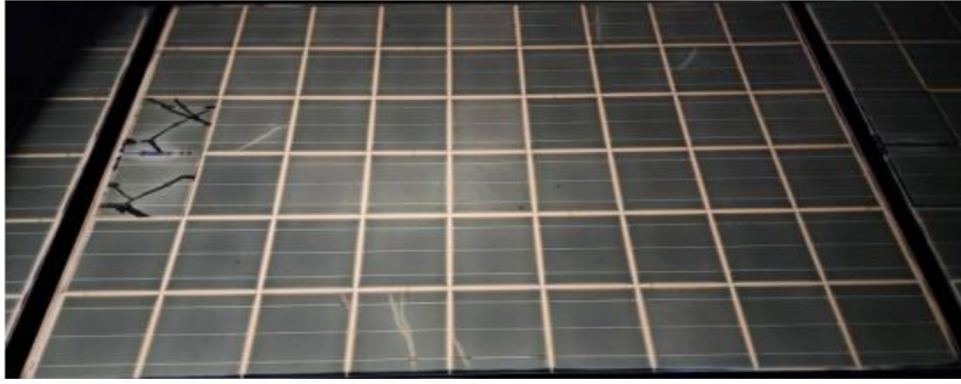
This discrepancy results in the manifestation of dark streaks or lines when observed under UV fluorescence. Nevertheless, both visual inspection and Infrared imaging techniques are also useful in identifying snail trails over an extended post-installation period. It is important to understand that snail trails have a negative effect on the performance of the PV module and can be used as a sign of moisture infiltration. This is frequently due to mechanical stress brought on by the loss of module hermeticity and cell breaking. This is discernible in UVFL imaging. [Figure 19b](#) illustrates cracks in four different cells on the PV module. These cracks can disrupt the electrical conductivity within the affected cell regions, resulting in a decrease in short-circuit current, an increase in series resistance, and thereby, in a reduction in the output power of the PV modules and, by extension, the entire PV array.

**Fig. 18.** UVFL image of a PV module affected by snail trails.

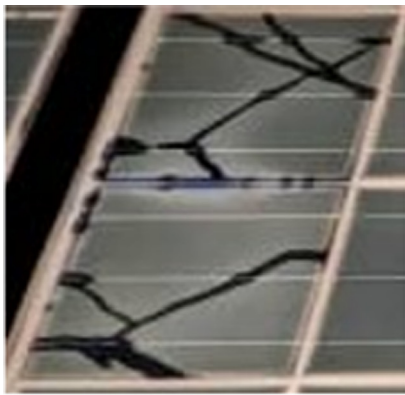
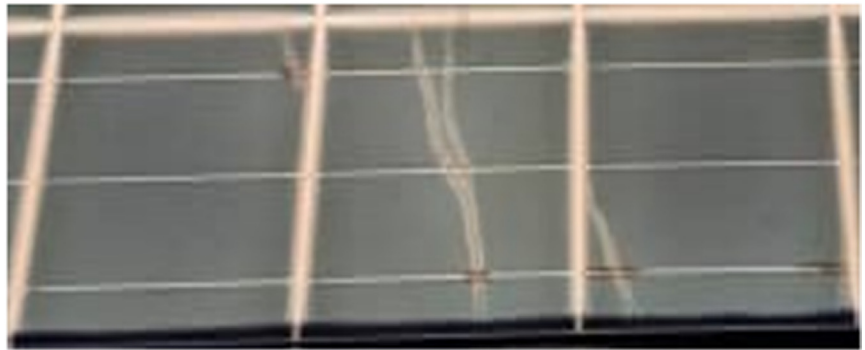
**(a) Snails trails**

**(b) Microcracks**

**Fig. 19.** UVFL image of a PV module: (a) affected by snail trails and (b) affected by microcracks.

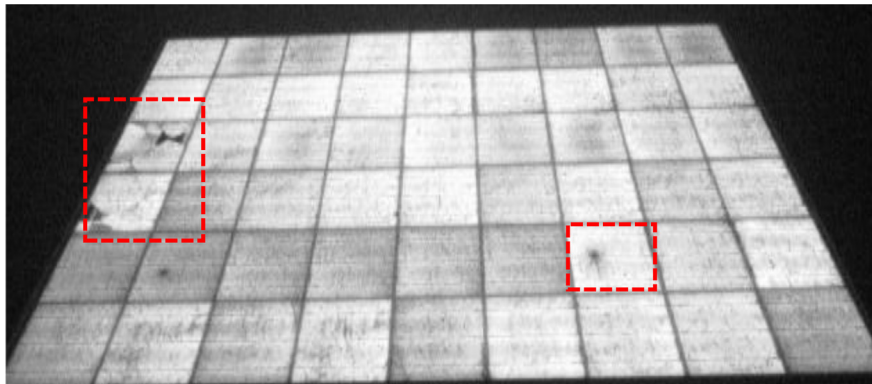
EL imaging technique enables a comprehensive understanding of PV module degradation modes. Therefore, EL analysis was conducted on field installed PV modules. To achieve this, the panel containing the snail trails for visual inspection was selected. A DC power supply was employed to pass a current equal to the rated short-circuit current of the module so as to achieve the forward biasing of the module. EL images were captured with an exposure duration of 10 seconds. Notably, since the modules within the site are affixed to the support structure, EL images obtained during the survey exhibit modules with a parallel orientation mounted on the structure. As depicted in [Figure 20](#), the extent of cracks within the module becomes readily discernible in these images.

**Fig. 20.** EL images for 54 cells of a polycrystalline module.

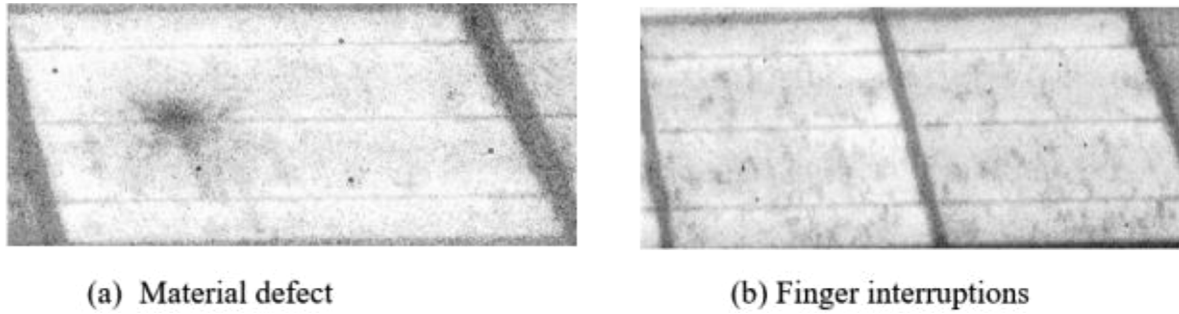
[Figures 21a](#) and [21b](#) show material flaws that resulted from the production process, most notably finger inter-ruptions. Unless they are caused by significant mechanical strain at the solder joints, these specific abnormalities normally do not shorten the operational lifespan of the involved solar panel. EL images reveal the presence of cracks in several modules. These cracks have been categorized into three groups, based on the extent of the affected area, as demonstrated in the EL image captured at the short circuit current, as depicted in [Figure 22](#): (a) Mode A – hairline cracks, without any dark area (b) Mode B – cracks associated with grey areas in the cell (c) Mode C – cracks associated with dark areas in the cell. Mode A cracks are typically regarded as harmless and do not impact the power generation of the modules. On the other hand, the dark regions associated with Mode B and Mode C cracks can result in power loss. This is because dark areas in electroluminescence images signify a disruption in the electrical connection to the affected region, thereby influencing the efficiency of the cell and the overall power output of the photovoltaic panel.

**Fig. 21.** Defects on solar cells.
