Strategy for simple, on-site failure analysis: investigating bubbles and burn marks in backsheets of PV modules

Bernhardt Käßer^{1,*}, Aline Kirsten Vidal de Oliveira²

Keywords: Field measurements / defect detection / backsheet degradation / inter-row spacing / PV operation & maintenance

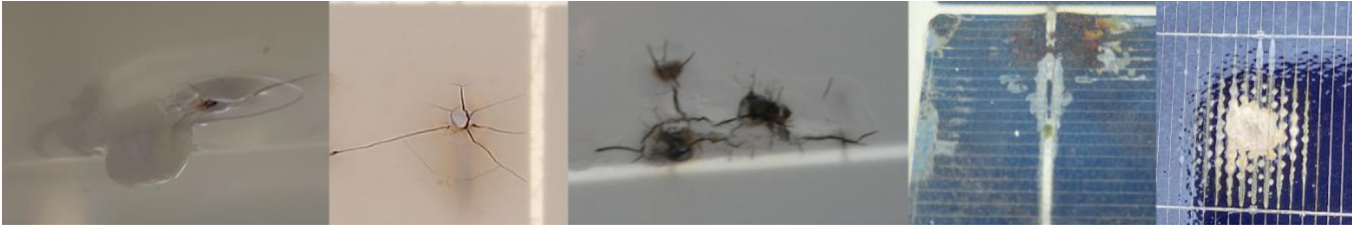
Fig. 1. Potential/observed consequences of (cyclic) shading: bubbles, blisters and burn marks.

Our study focuses on a specific, yet frequently overlooked, degradation pattern: the formation of faults in PV module backsheets, which we hypothesize to be induced by localized thermal stress from cyclic partial shading. The approach acknowledges that observed anomalies may function both as root causes of system degradation and as indicators of existing malfunctions or suboptimal component interactions. As a case study, we examine modules exhibiting anomalies on both the front and rear sides, as initially reported by plant operators, with the underlying cause remaining unidentified (Fig. 1).

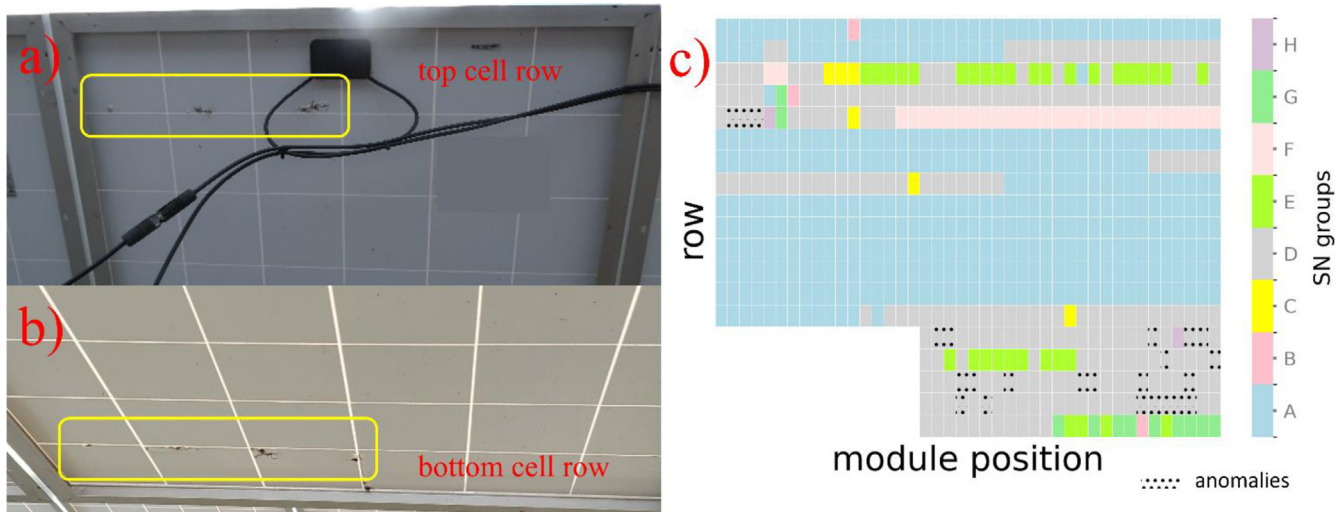
group D, which accounts for approx. 34% of the modules inspected. Figure 2 shows the distribution of the SN groups and the positions of the anomalies on a map. So far, no particular physical locations, e.g., row ends, have been identified as more sensitive to form burn marks. In Germany, however, the positions of faulty modules often correlated with the most exposed positions in the hilly topography of the PV plant.

Fig. 2. Typical positions of faults, top cell row on junction box side (a) and bottom cell row opposite junction box side (b), mapping of batches and marking modules with anomalies at the Brazil 1 site (c).

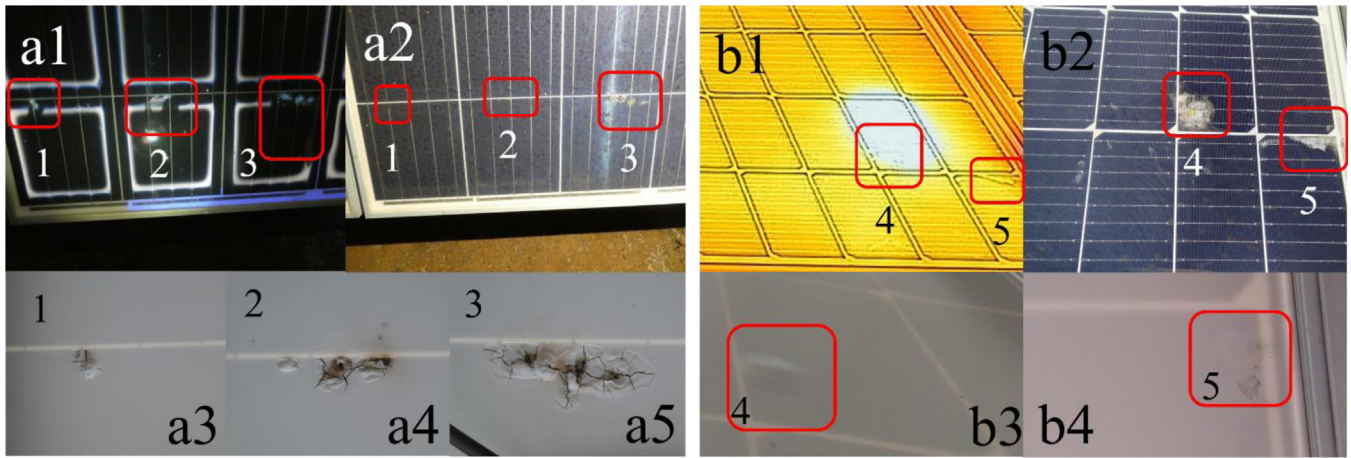
Fig. 3. Comparison of UVF and IR imaging for two modules. UVF image with 3 defects (a), IR image with two defects (b), with corresponding front and rear (images horizontally flipped) VIS. Numbers 1-5 identify the same areas.

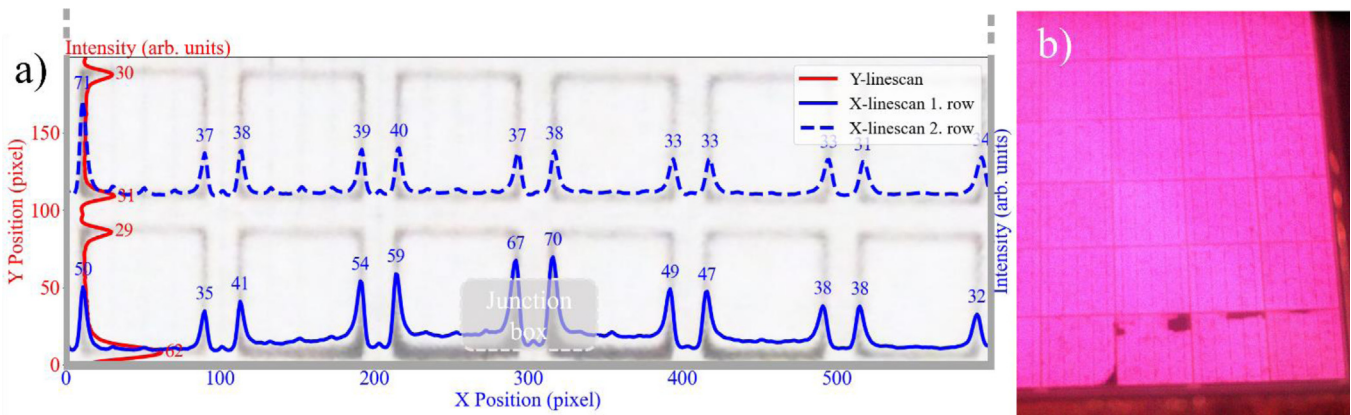
intensity along both the horizontal and vertical axes of the two outermost module rows and to a lesser extent also visible in the peak broadening (Fig. 4). While edge effects exhibited a similar trend, their magnitude was significantly lower and thus insufficient to account for the observed intensity increase. A paired sample t-test comparing the last and second-to-last intensity peaks of ten modules yielded a p-value of 1.4×10^{-6} , confirming the statistical significance of the increased UVF intensity. In contrast, modules from other PV sites showed no such effect (p-value = 0.48). Furthermore, an around 30% increase in UVF intensity was consistently observed in the central region of the first cell row, aligning spatially with the junction box. IR images confirmed elevated temperatures at these junction box positions. This phenomenon strengthens our hypothesis of the presence of elevated temperatures at the edge cells correlating with increased UVF intensity. Due to a combination of lower UV exposure and the relatively short operation time, UVF imaging did not reveal strong fluorescence patterns in Germany. In Figure 3, the IR image (b1) shows an apparently larger affected area because the thermal anomaly extends beyond the visibly degraded region seen in VIS and UVF (b2–b3). This difference reflects the distinct sensitivities of the techniques: IR imaging captures heat diffusion, whereas VIS and UVF reveal only the localized polymer damage. Furthermore, IR imaging in Germany (Fig. 3b) identified 39 anomalies (overheated cells, hot spots etc.), with 30% exhibiting faults also showing corresponding IR anomalies, reinforcing the association between thermal stress and localized material failure further.

Additionally, EL images of the affected modules showed electrically inactive cell areas (Figs. 4b and 5 presenting three examples). The edges of the peripheral cells appear dark in EL images, indicating electrically deactivated regions. In contrast, the central cells remained unaffected, as confirmed by EL images of sample modules (one example in Fig. 3c). These defects are highly concentrated in specific areas and align with

anomalies found in VIS and anomalies visible in UVF (Fig. 4).

Fig. 4. Two complementary techniques indicating elevated temperatures and faults in bottom cell rows for two different modules: UVF image of the two outer-most cell rows (negative for enhanced visibility) and corresponding mean intensity along horizontal and vertical axes of modules (a), EL-images showing inactive areas (b).

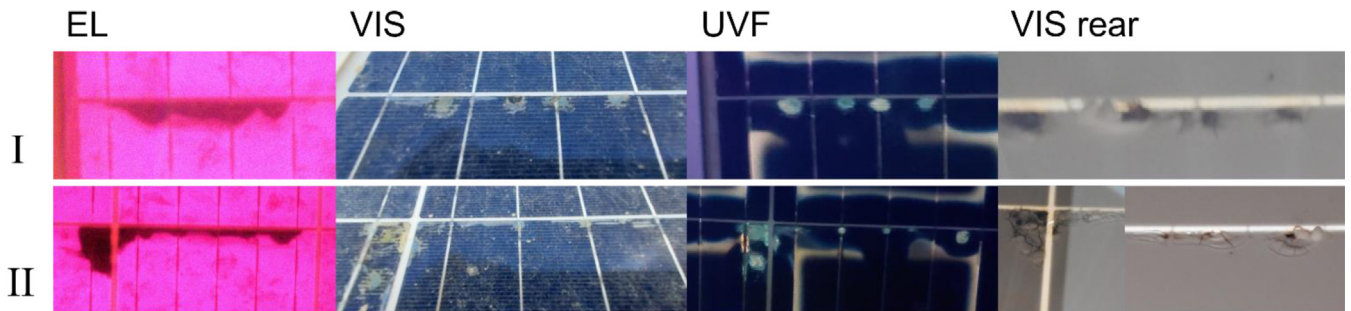
Fig. 5. Visualization of cell parts affected with anomalies (top and bottom row) for two exemplary PV modules I and II, from left to right: EL, VIS, UVF from the front and VIS from the rear (rear VIS images horizontally flipped).

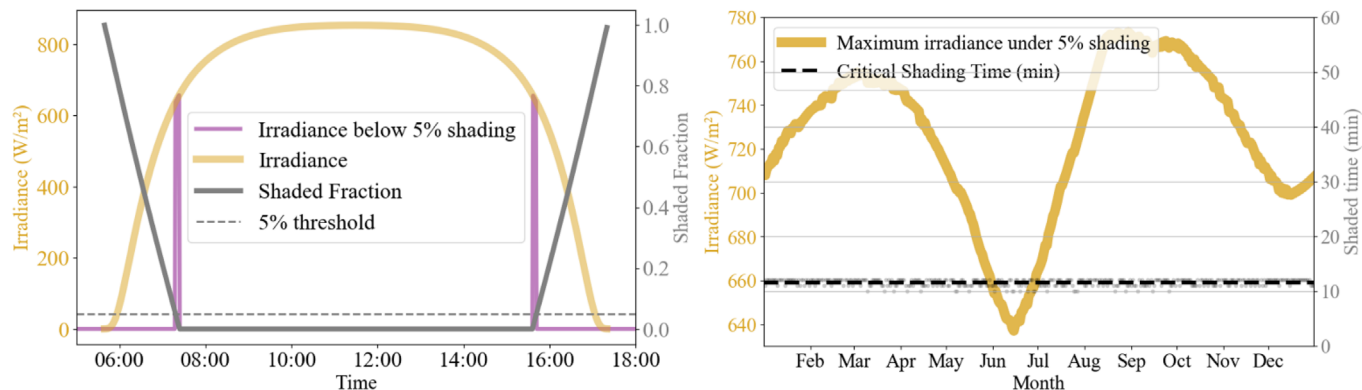
Fig. 6. Calculated irradiances and shaded fractions in Brazil; shading fractions below 5% highlighted on 2024.06.01 (left); maximum irradiance and shading time below 5% throughout 2024 (right).

junction boxes consistent with localized thermal differences. Also, shading and irradiance modeling confirm consistent shading of bottom/top cell rows with irradiance levels reaching up to 770 W/m². The partial shading induced reverse bias in the affected cells, concentrating current density particularly at the vulnerable areas of the module, particularly cell edges and soldering points potentially due to variations in material selection or manufacturing parameters. Literature reports that reverse-bias hot-spots in c-Si modules can exceed ~100°C at the cell that were observed in controlled hot-spot endurance tests; front-surface IR typically underestimates cell peak temperature due to the glass cover and lateral heat spreading [34–36].
