# Failure mode analysis of Austria’s first road-integrated photovoltaic system

Alexander Erber\*

Competence Field Renewable Energy Technologies, University of Applied Sciences Technikum Vienna, 1210 Vienna, Austria

**Abstract.** The exploration of traffic areas as a novel photovoltaic integration opportunity within the traffic sector, specifically in road surfaces, has been demonstrated in various projects. Limited data and publications about the performance and failure modes of these innovative road-integrated modules highlights the need for a comprehensive failure analysis. This study focuses on first time assessing failure modes of road-integrated photovoltaic modules installed at Austria’s first road-integrated PV system in Teesdorf. A comprehensive failure mode analysis is conducted at the 100 m<sup>2</sup> PV parking place using a combination of quantitative and qualitative methods. These methods include regular visual inspections, I-V-curve measurements at both string- and module-levels (with a simplified STC correction), electroluminescence- and dark-I-V-curve measurements, and the use of monitoring data. The PV parking place produced 10.2 MWh in its first operation year

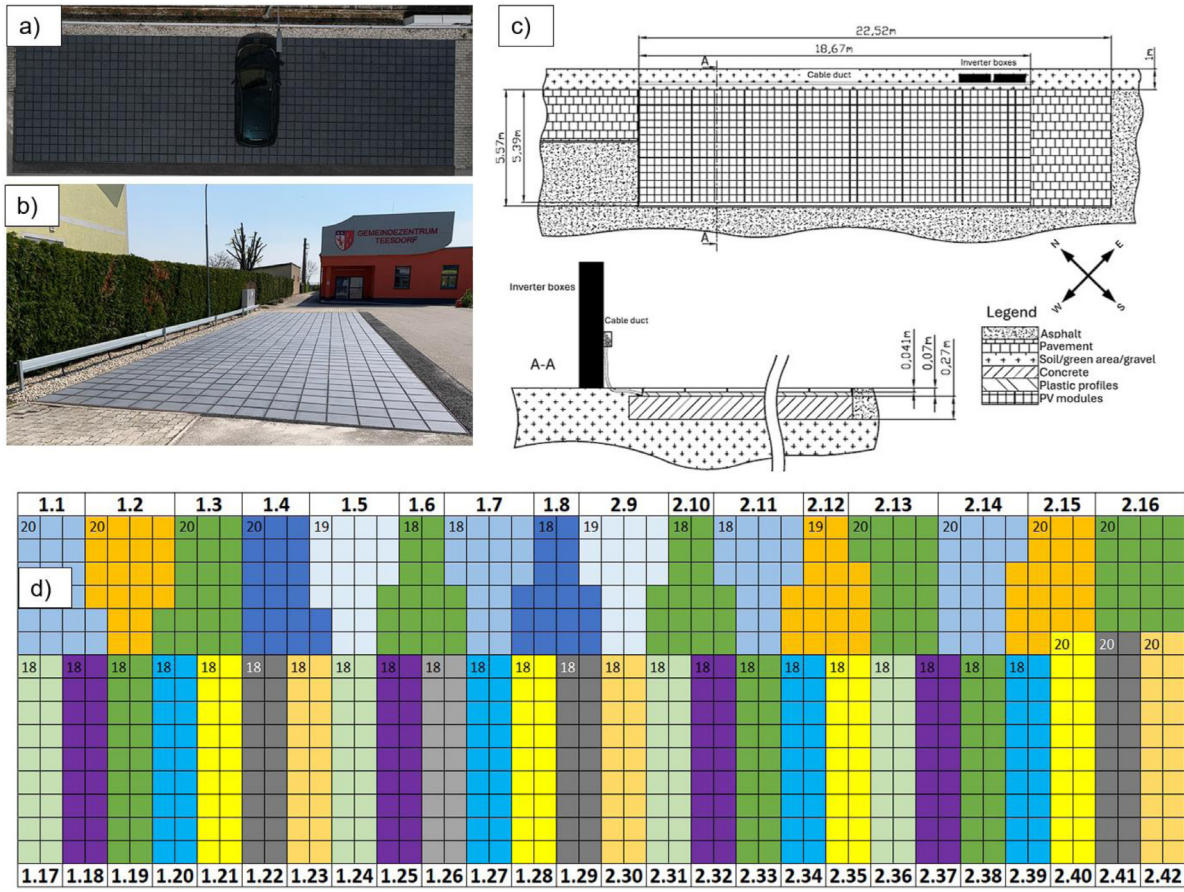
The PV parking place in Teesdorf (Austria) was commissioned in May 2022 on an already existing parking place in front of the community centre in Teesdorf (see Figs. 1a and 1b). The location was chosen due to the fact that the parking lot for the public building is mainly used in the evening when different kinds of events take place. During daytime, the parking lot is only used rarely and allows the area to be utilised for photovoltaic power generation during that time. From a research point of view, this is an attractive constellation as the performance during daytime and the vehicle loads during nighttime can be investigated at one location.

For the construction of the site, the existing pavement, together with the substructure, was removed and replaced by a concrete foundation. Plastic profiles were then mounted on the foundation, and the PV modules were placed on top of them (see Fig. 1c). The profiles were mounted with according spacing, so that every module had contact with three profiles (one on each edge and one in the middle) for a better load transfer to the concrete foundation. This allowed an easier cable management and enables the placement of sensors below the modules after commissioning.

The whole systems consist of 780 commercially available four cell RIPV modules, with a load capacity of two tonnes according to the manufacturer. Each module has a nominal power of 21.52 Wp and consists of a glass-foil assembly on the top and a polymer composite substructure. Further module data is presented in Table 1. The module does not have a certification according to IEC 61215. To reach the operating voltage range of the used IQ7+ Enphase<sup>®</sup> microinverters [25] the modules were connected to strings of 18 to 20 modules. In the layout of the string plan factors such as shading due to nearby buildings and possible parking cars, the inverter input parameters and safety parameters (OVE E 8101 [26]) were considered. The connection of the modules in the strings was made through 3M<sup>TM</sup> Scotchlok<sup>TM</sup> MGC connectors. Each of the 42 strings is connected to one IQ7+ microinverter. Figure 1d shows the string layout with the labelling of the strings and the number of modules in one string.

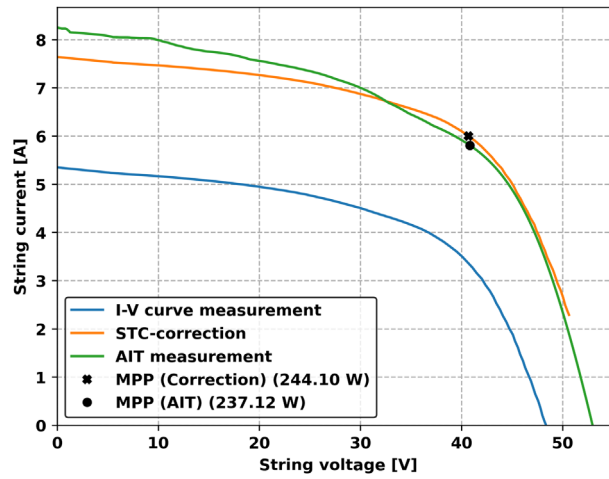
**Fig. 7.** Validation of the simplified STC correction of the string I-V curve measurement (outdoor) of string 2.40 with the calculated string I-V curve from the AIT module measurements (indoor).

Figure 7 shows the measured outdoor I-V curve, the STC corrected string I-V curve and the calculated string I-V curve based on the AIT measurements in 2023 of string 2.40

The deviation of the AIT I-V curve from the STC corrected string I-V curve at lower string voltages, which does not affect performance, can be explained by faulty bypass diodes in the modules of string 2.40. As a result, the weakest module limits the string power at lower voltage values. This was not considered when creating the I-V curve based on the AIT measurements. No extrapolation was carried out for the STC-corrected characteristic curve in the open-circuit voltage range, as this was not required for validation.

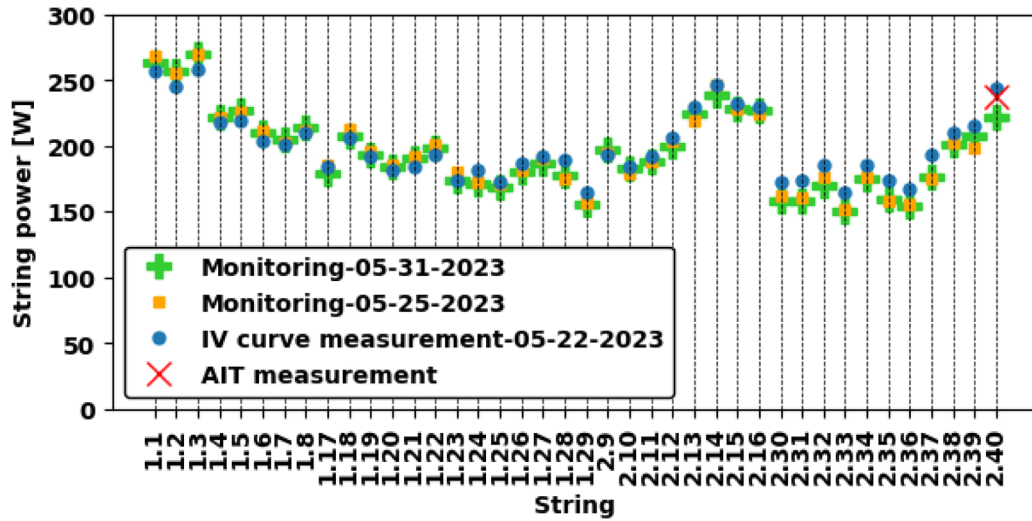
**Fig. 8.** Validation of the STC corrected monitoring data with the STC corrected string I-V measurements (outdoor) and the AIT measurement (combined string I-V curve; indoor) based on the string MPP powers.

Figure 8 shows the validation of the monitoring data STC correction with the STC-corrected MPP powers of the string I-V curve measurement (outdoor). For this purpose,

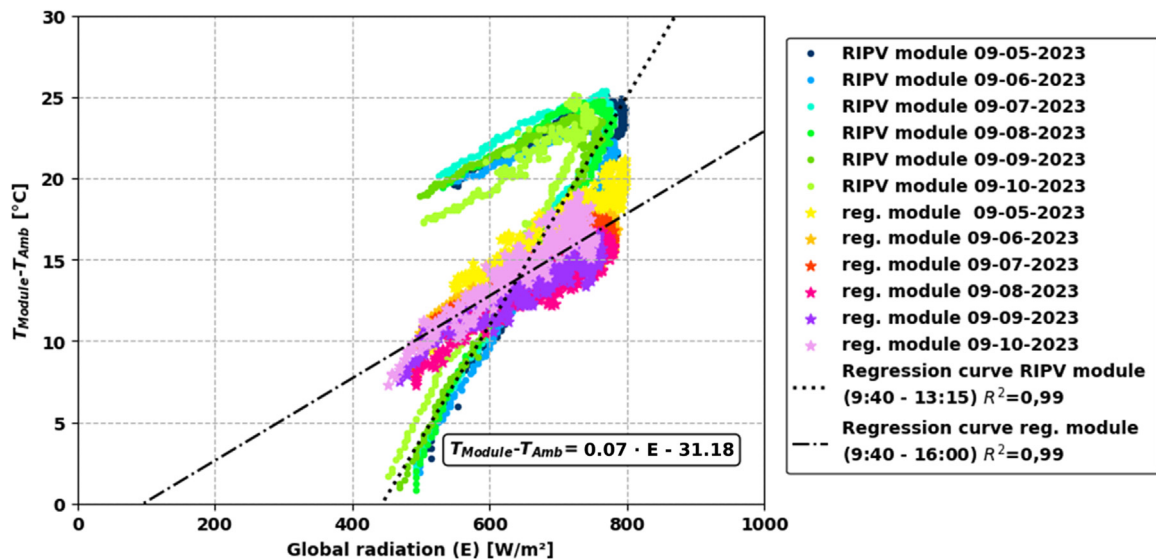
**Fig. 12.** Temperature behaviour of the analysed road-integrated PV module (RIPV) and a regular (reg.) module from 09:40 to 16:00. Regression curves for both modules and the regression parameters of the temperature model for the RIPV module.

The measurement results in the form of the irradiation-related module temperature increase ( $T_{Module} - T_{Amb}$ ) as a function of the global radiation for six September days (clear-sky days) are shown in Figure 12. In addition to the temperature behaviour of the RIPV module, the temperature behaviour of a regular PV module is illustrated. The temperature behaviour of the standard module can be described by a straight line with an origin near the zero point (offset of approx. 2.5°C). The reasons for the deviation of the regression curve from the intersection point at the zero point are the short period for modelling and the scattering of the measurement data due to the cooling influence of the wind.

capacity. At over  $650 \text{ W/m}^2$ , the temperature of the RIPV module rises above the temperature of the regular module as there is no rear ventilation. The temperature rise of the RIPV module in the morning shows a higher gradient than the temperature decline in the afternoon. This indicates that the heat capacity of the module must be considered when developing a temperature model for an annual simulation of RIPV systems. However, as the temperature model in this work is only used for the simplified STC correction, the temperature behaviour in the afternoon is not considered further.
